Regional Seminar, Russia, June 2014
UHF PD GIS monitoring
Thomas Linn, Qualitrol

GIS PD case studies

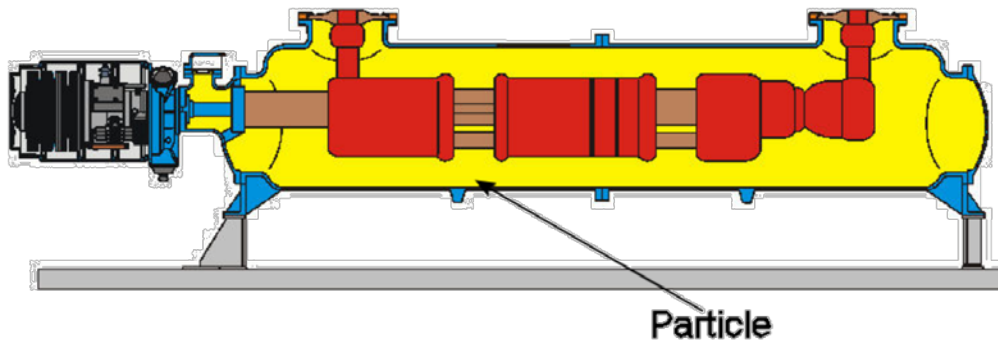
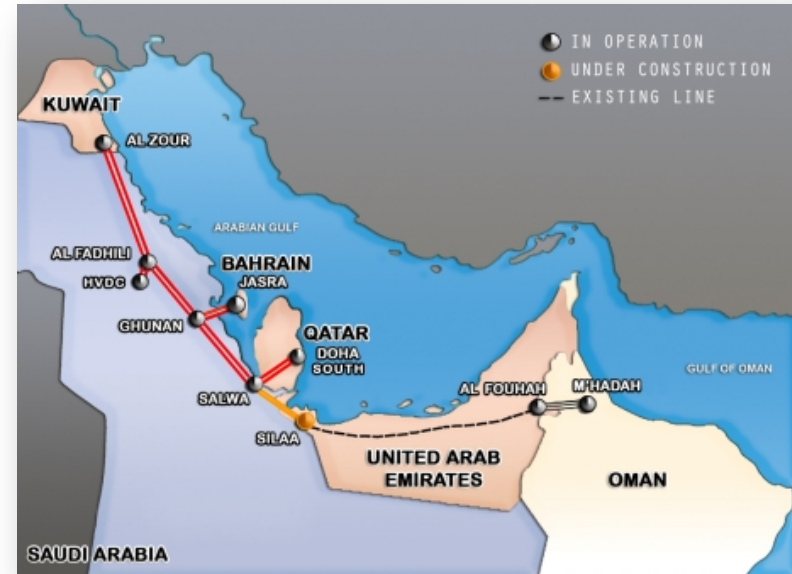
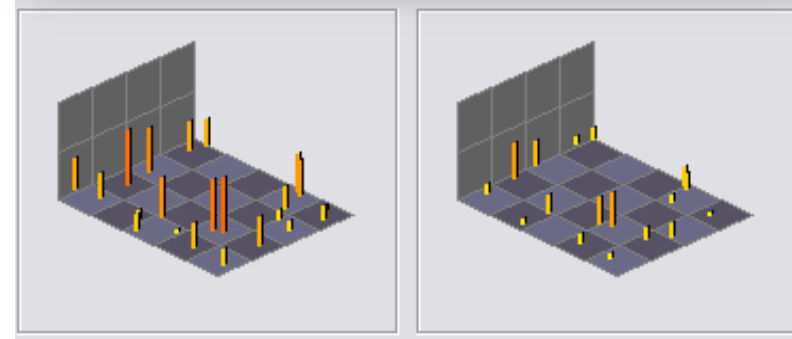
- Ghunan 400KV GIS, Saudi Arabia
 - One of the substation in GCCI link
 - During conditioning at 130KV, PD activity was observed in circuit breaker
 - When the CB was opened a metallic particle (1-2mm in length) was found
 - Fault detected, and located by Qualitrol PDM system and services
 - Saved utility from a faulty installation

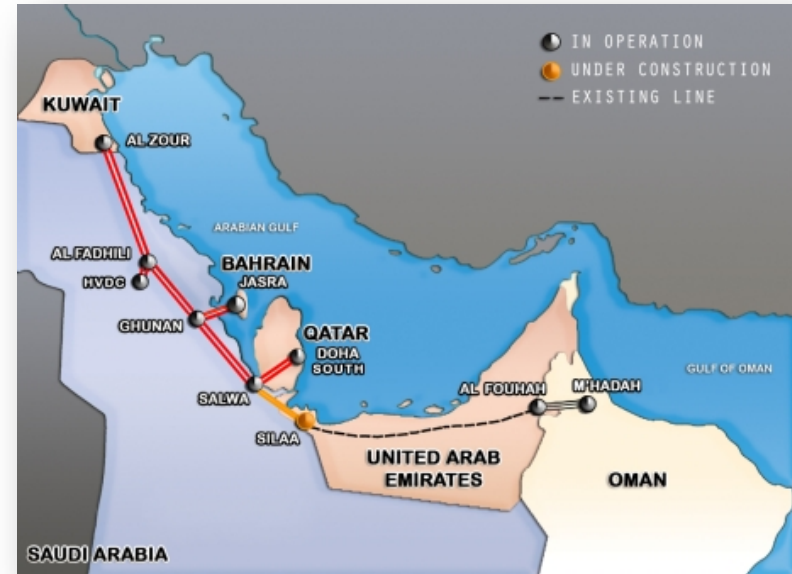
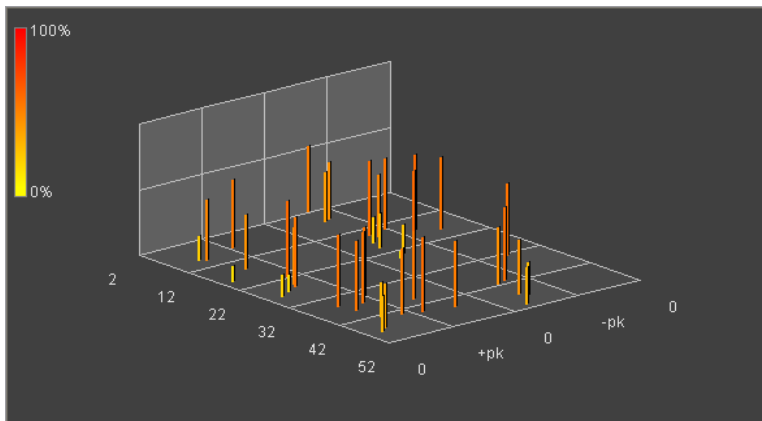
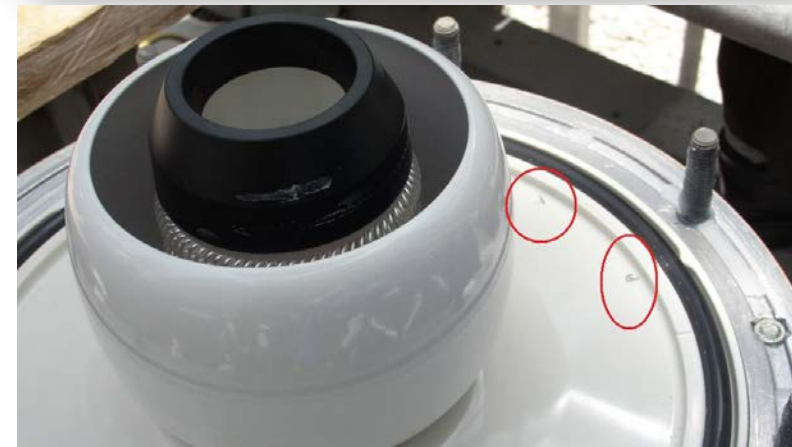
- Al Jasra 400KV GIS, Bahrain
 - One of the substation in GCCI link
 - PD activity was observed during operation
 - Fault detected, and located by Qualitrol PDM system and services
 - Investigation indicated surge arrester was the source of the signal
 - Saved utility from potential outages and loss of

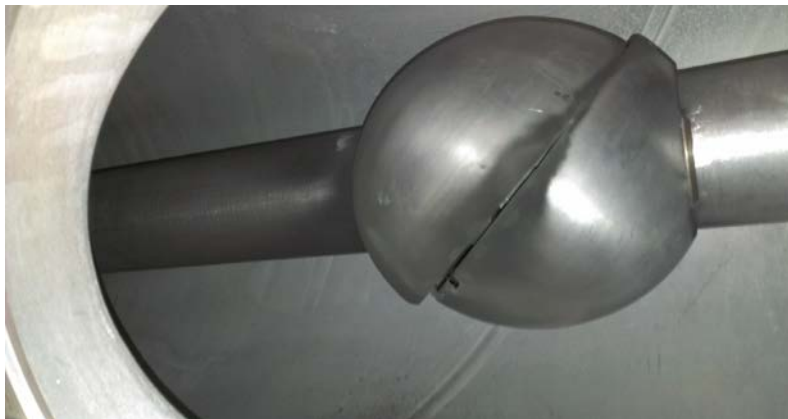
Stress Cone Fault (2012)

- Nuclear Power Plant, UK
 - Net electrical output: 1190 MW
 - Palm Joint Fault (1994)
 - Stress cone failure (in 2012)
 - Fault detected by Qualitrol PDM system and located prior to flashover
 - Saved potential loss of £250K per day for the utility (due to the loss of power supply)

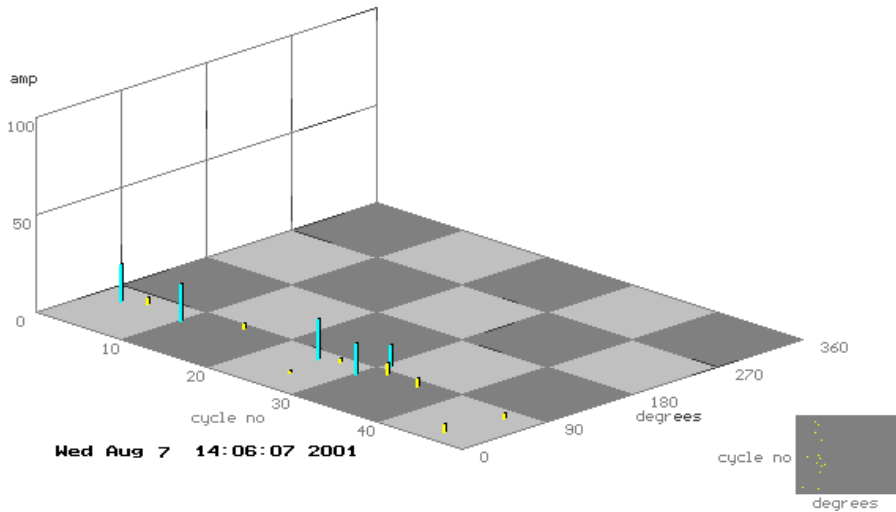
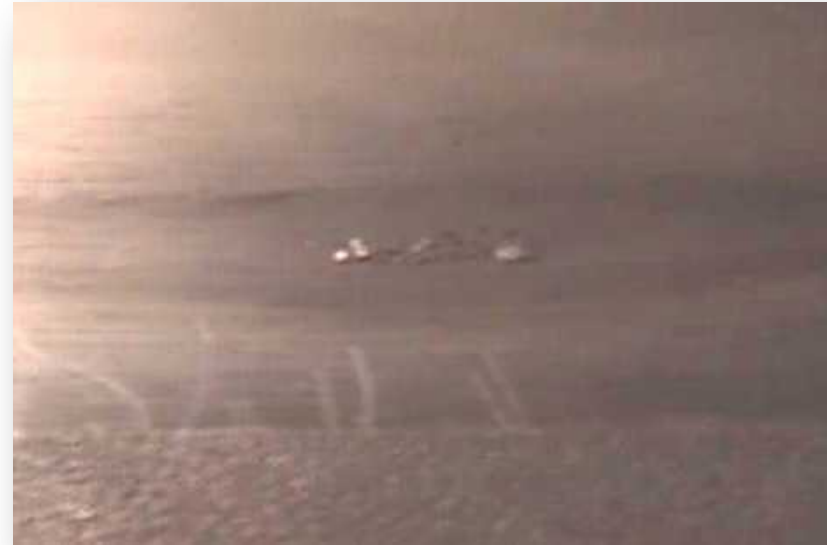
I) Breaker 85L02 S phase Corona per particle in the housing

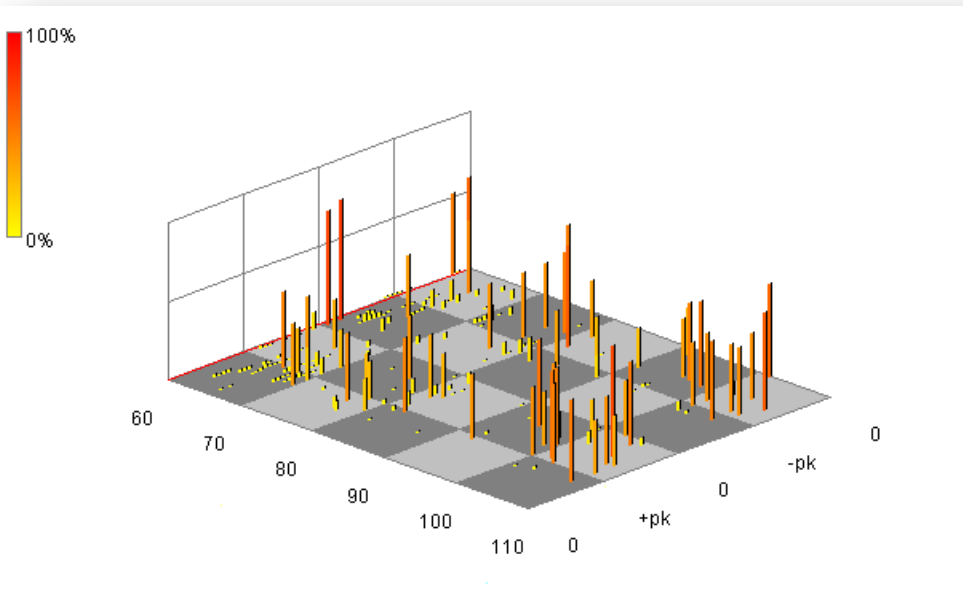
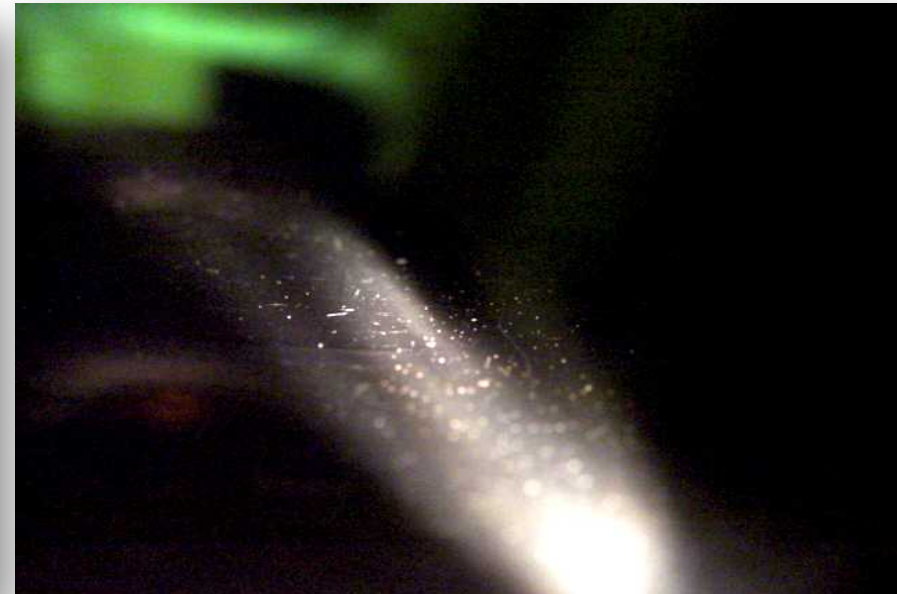
III) Breaker 86LI2 S phase Particles detected after operation

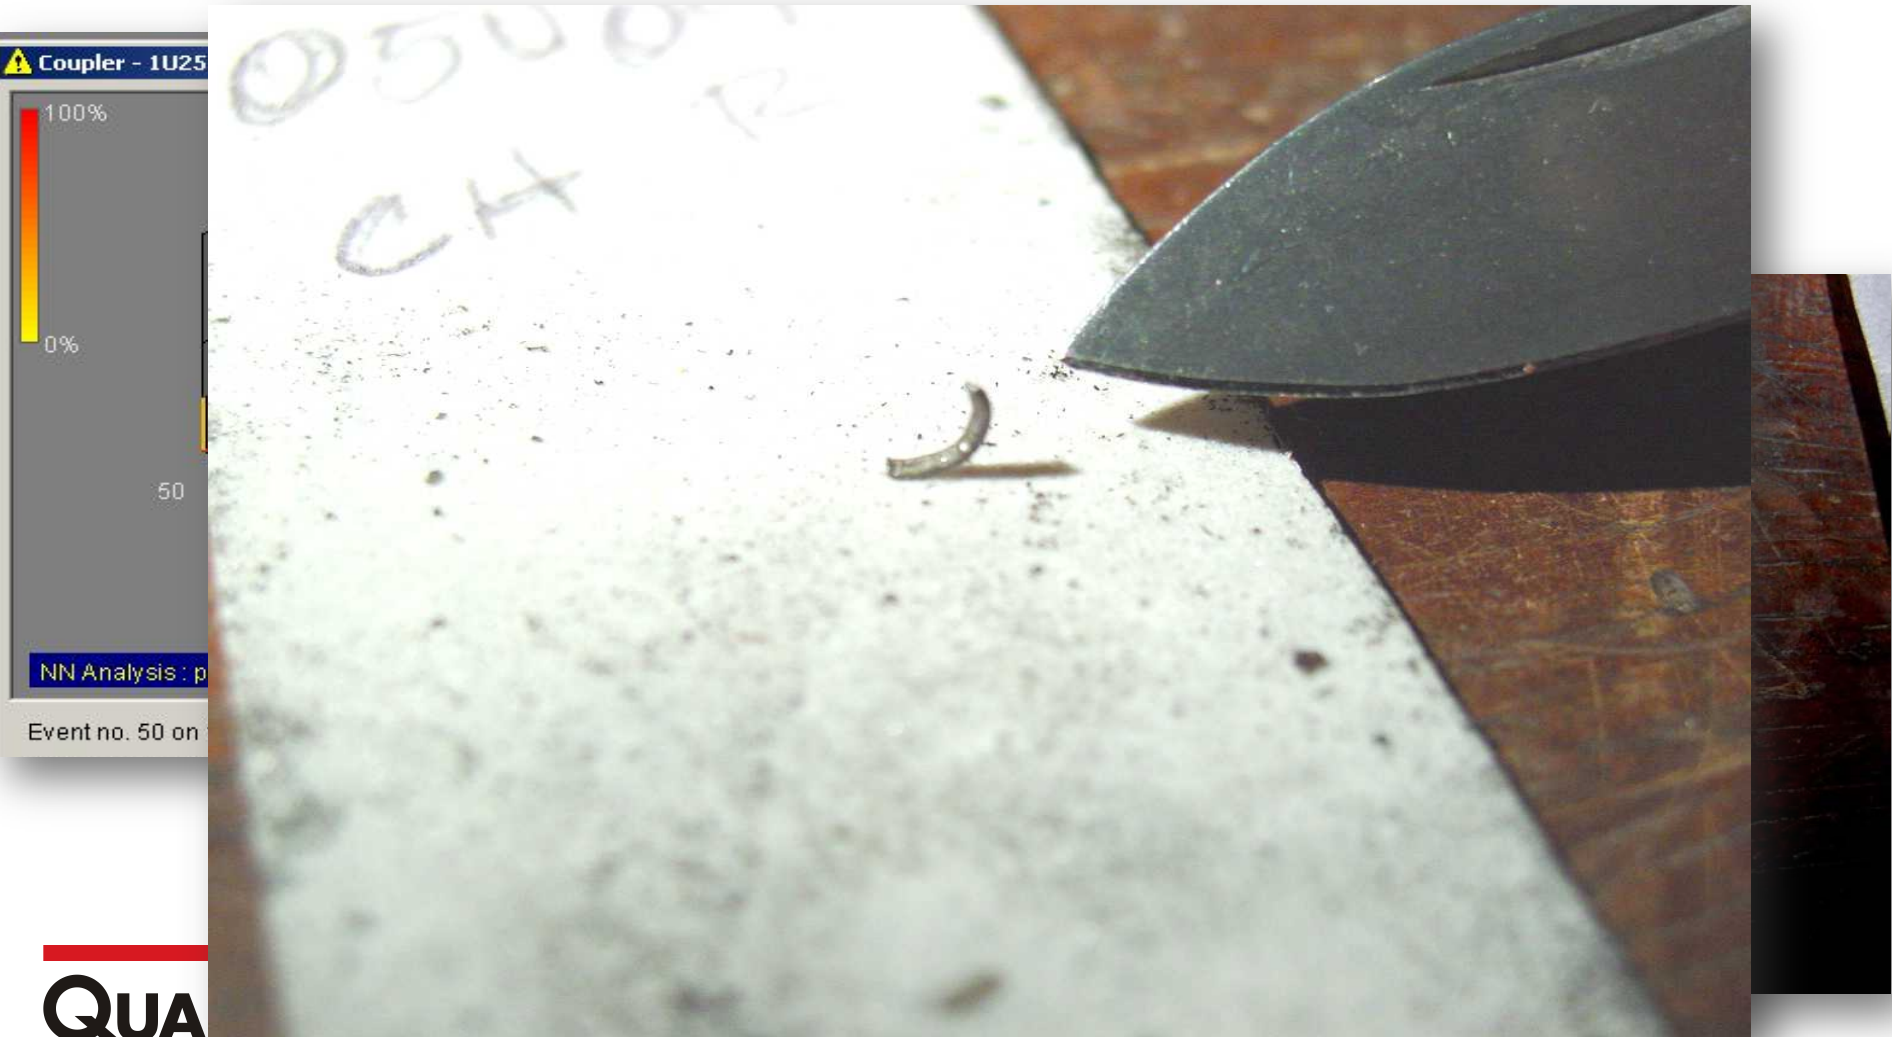
IV) Breaker 05U09 R phase particles

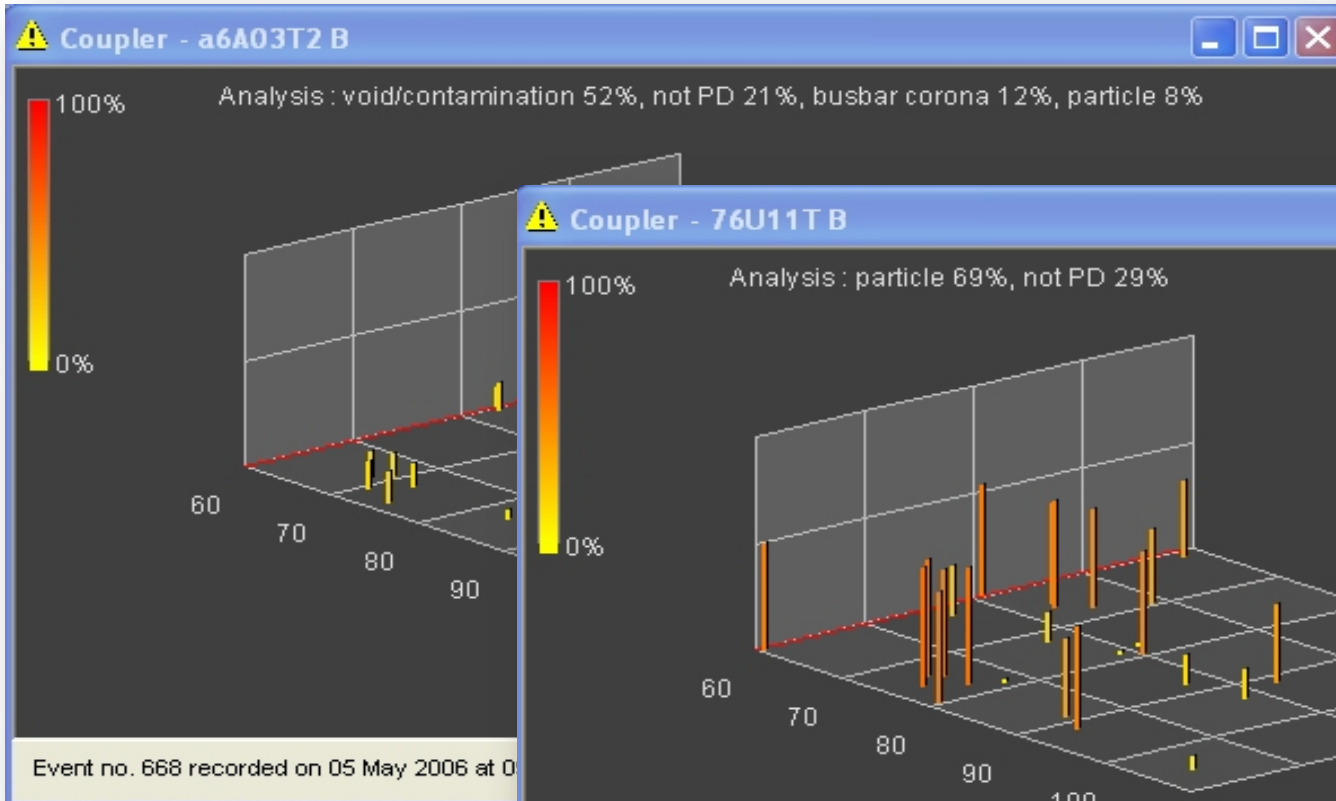
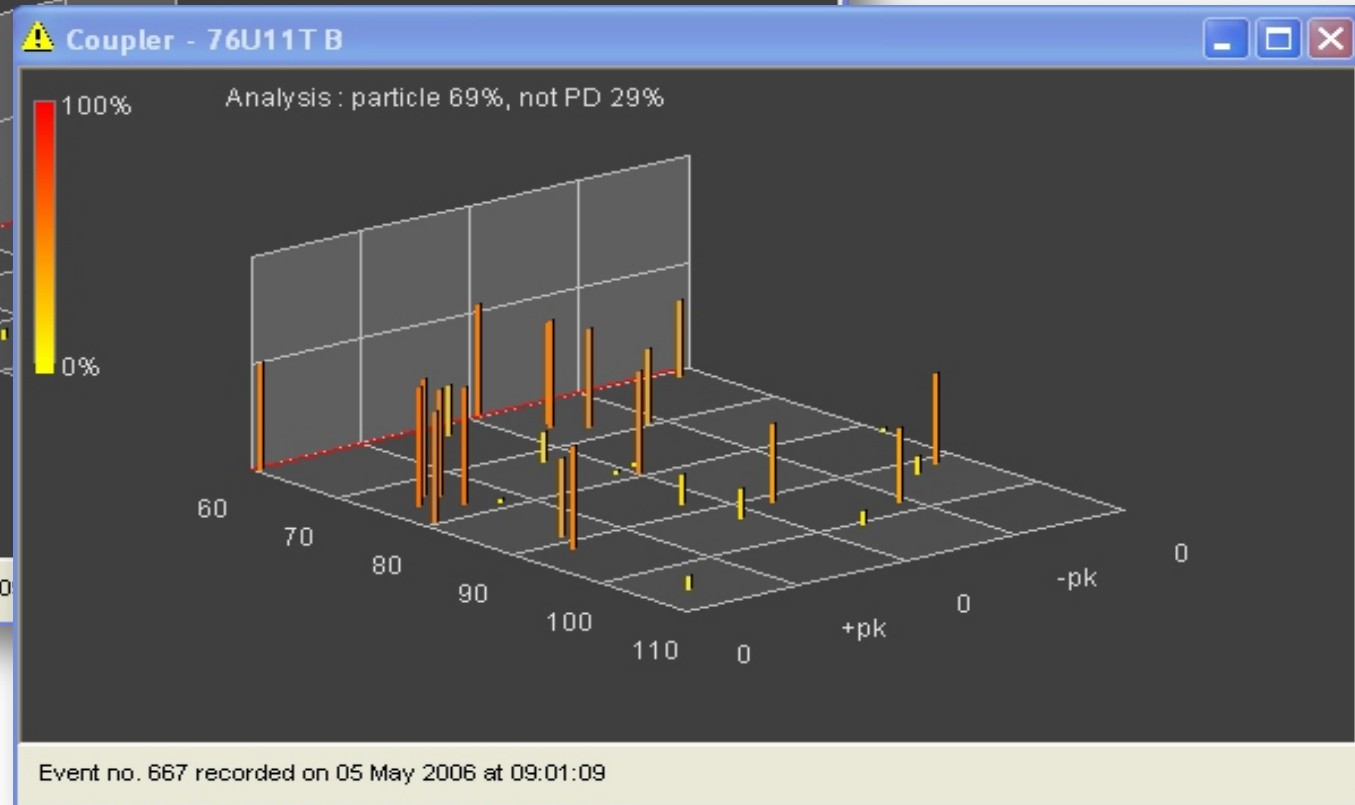
V) Surge Arrestor A34-T1 Phase T

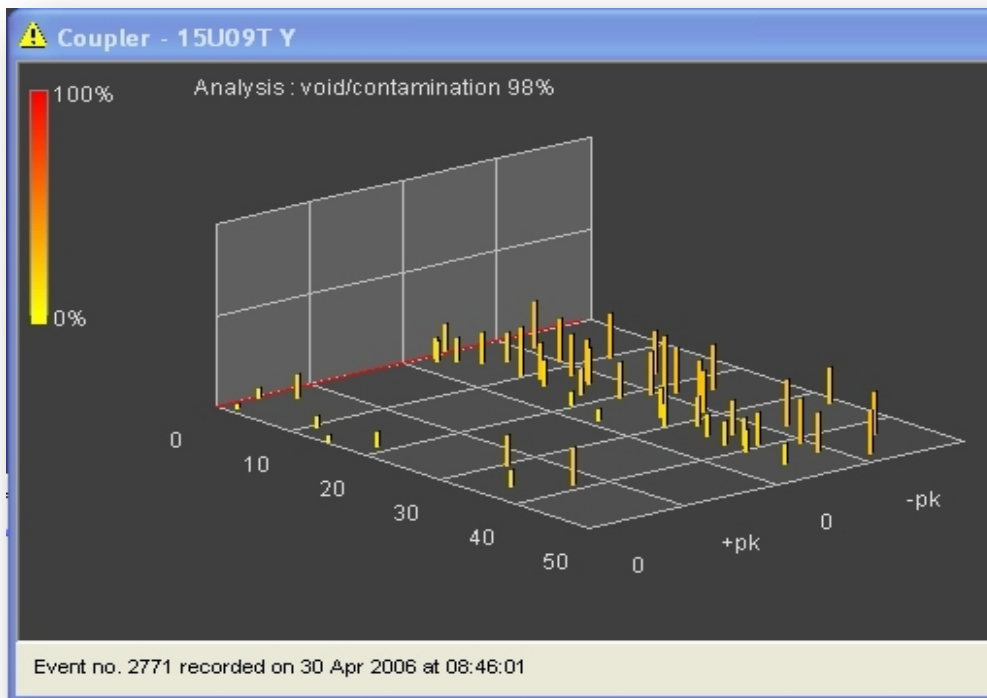
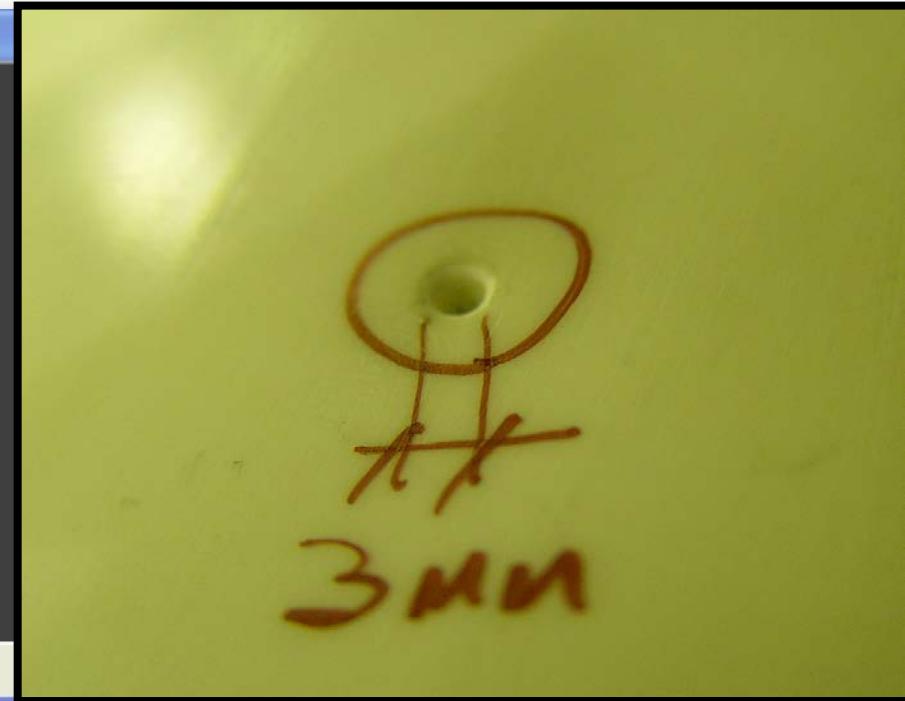
VI) Barrier (Disconnect Switch 55U9A) Bubble (void) in the resin epoxy / support insulator

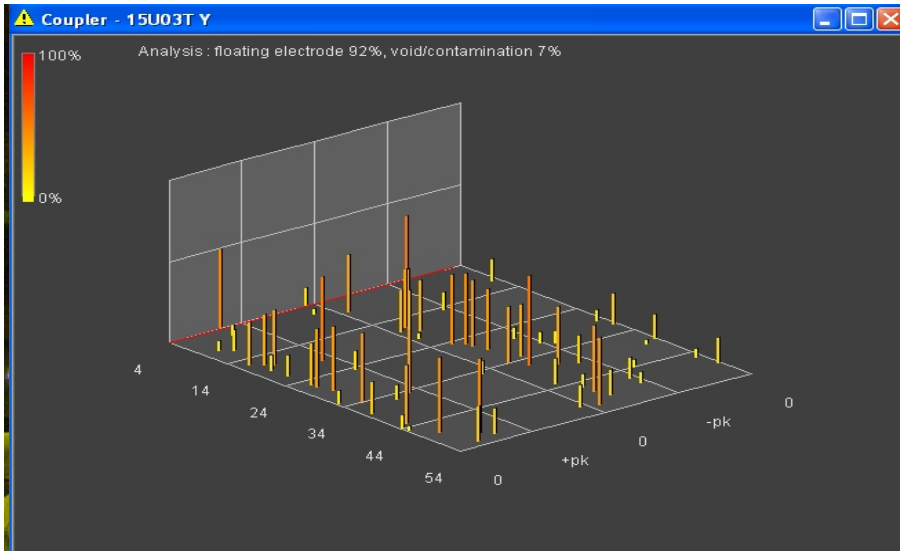
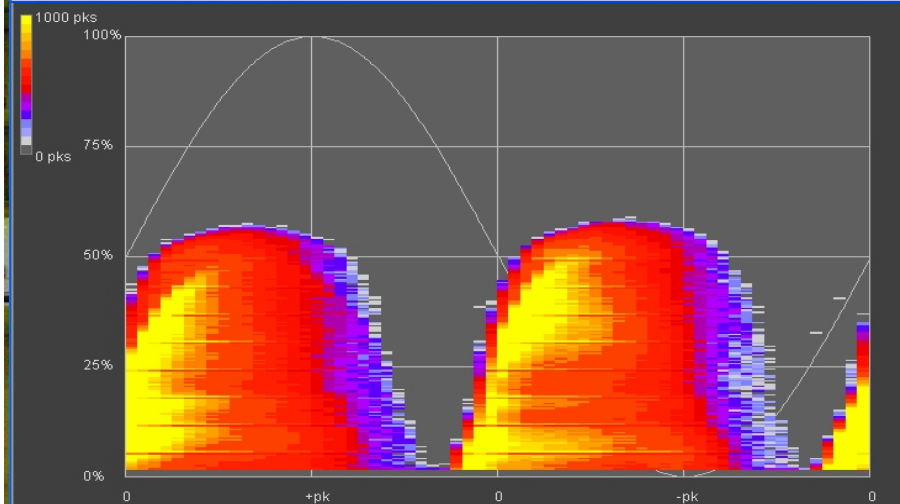
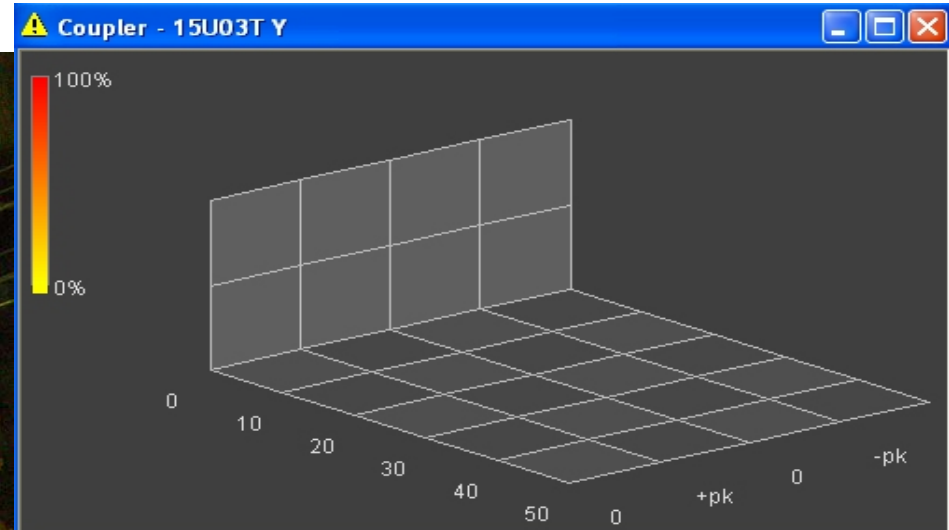
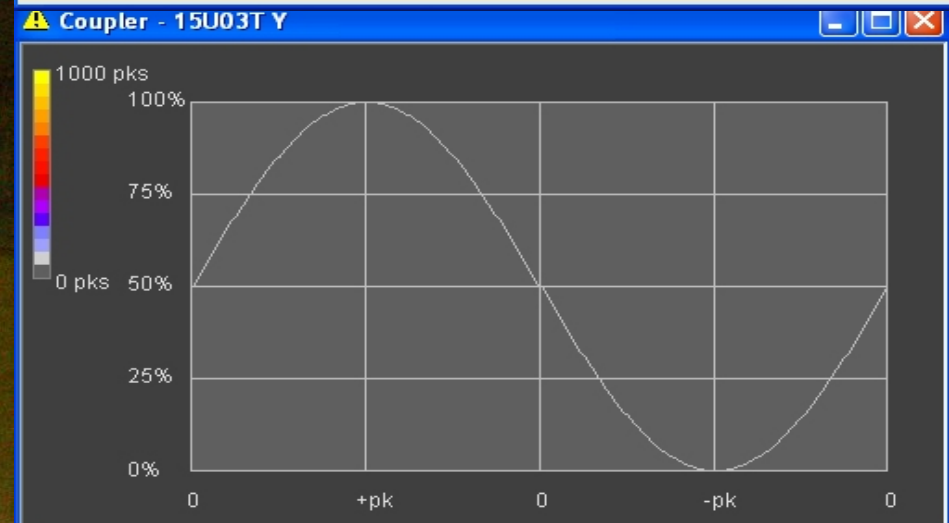
VII) Surge Arrestor A10 T1-S phase S

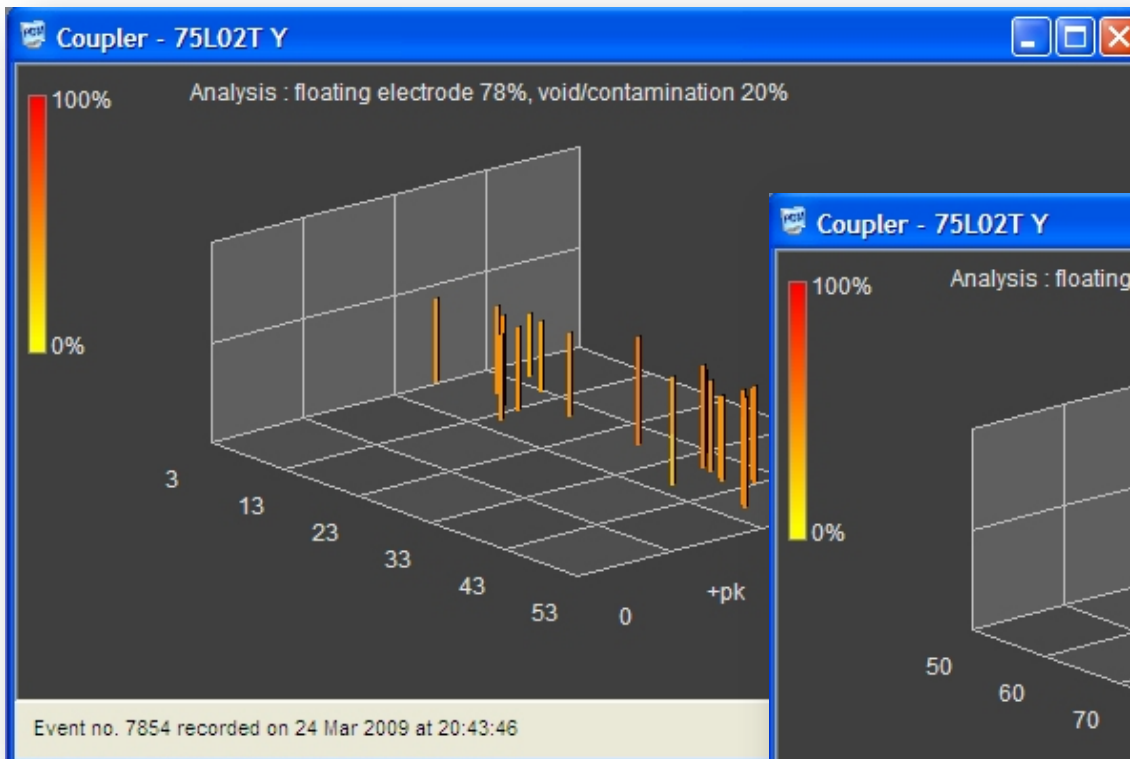
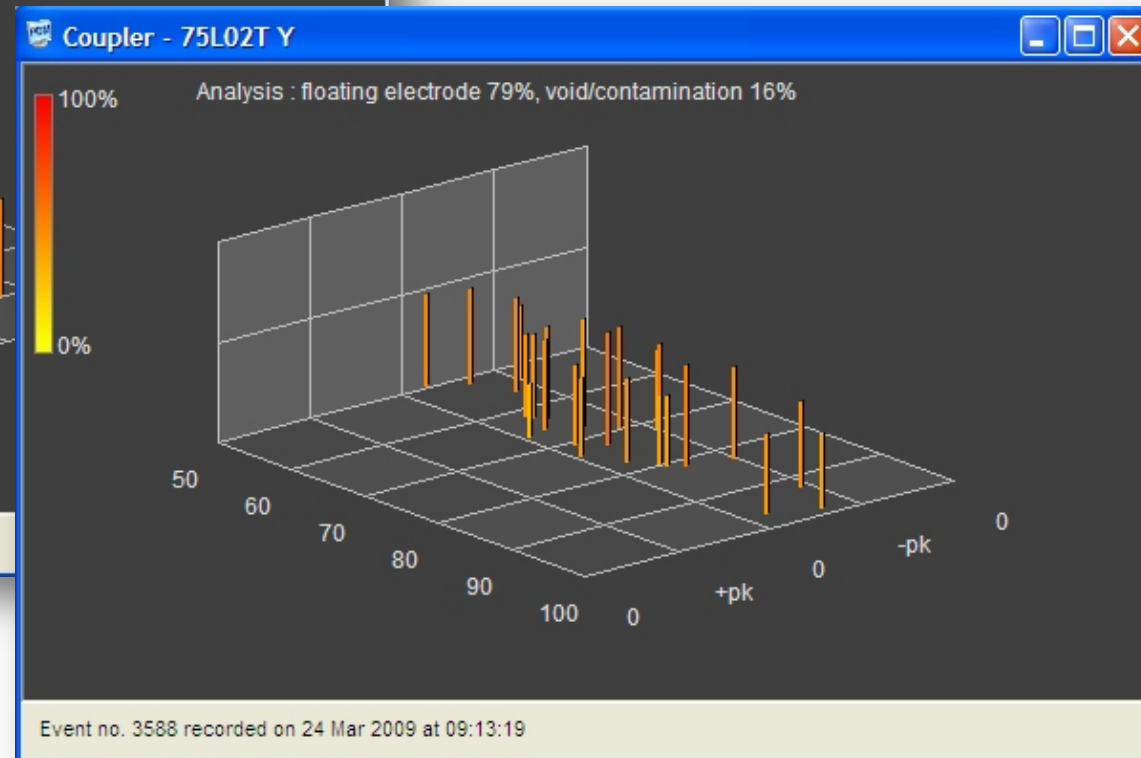
VIII) Conductor on line 2, output bus phase S Floating electrode

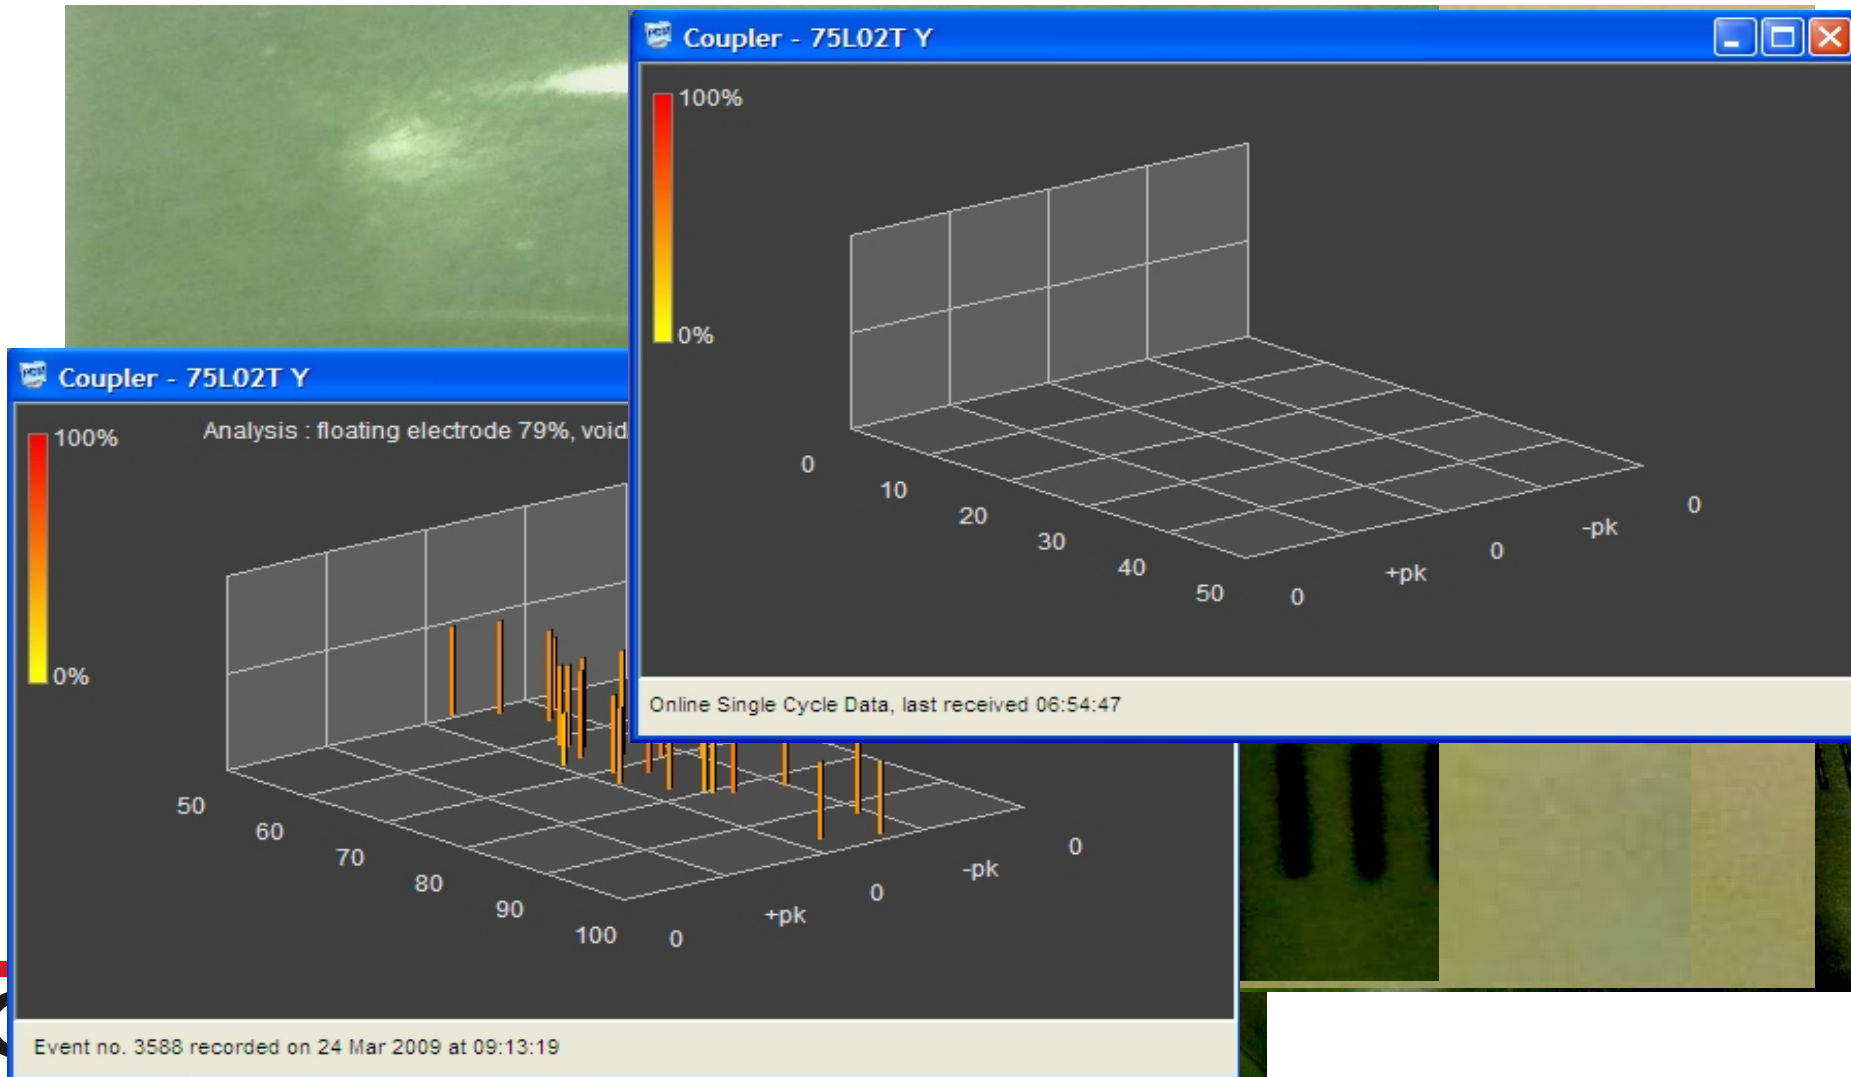
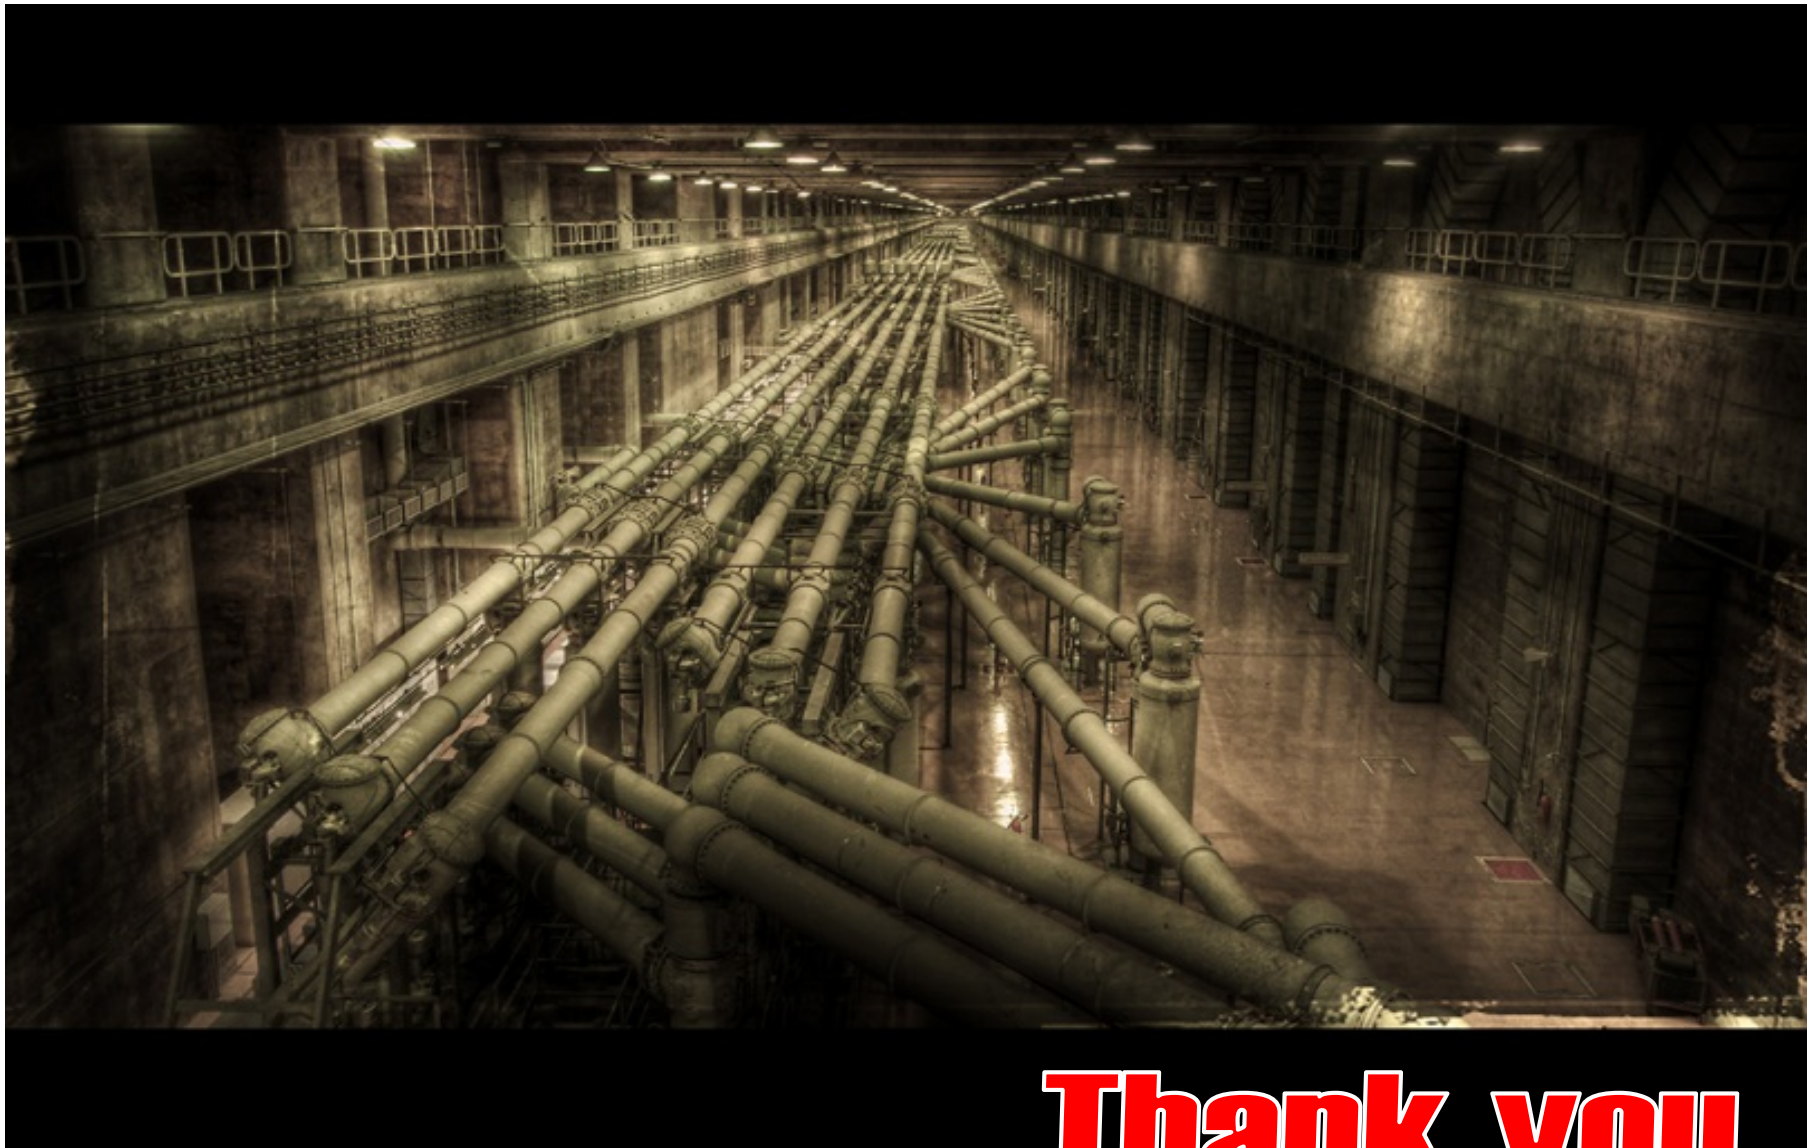
VIII) conductor line 2 output phase S Floating electrode
